## Adams Street at Granite Avenue Collision Diagram

**Howard/Stein-Hudson Associates, Inc.**  
38 Chauncy St., 9th Floor  
Boston, MA 02111  
617.482.7080

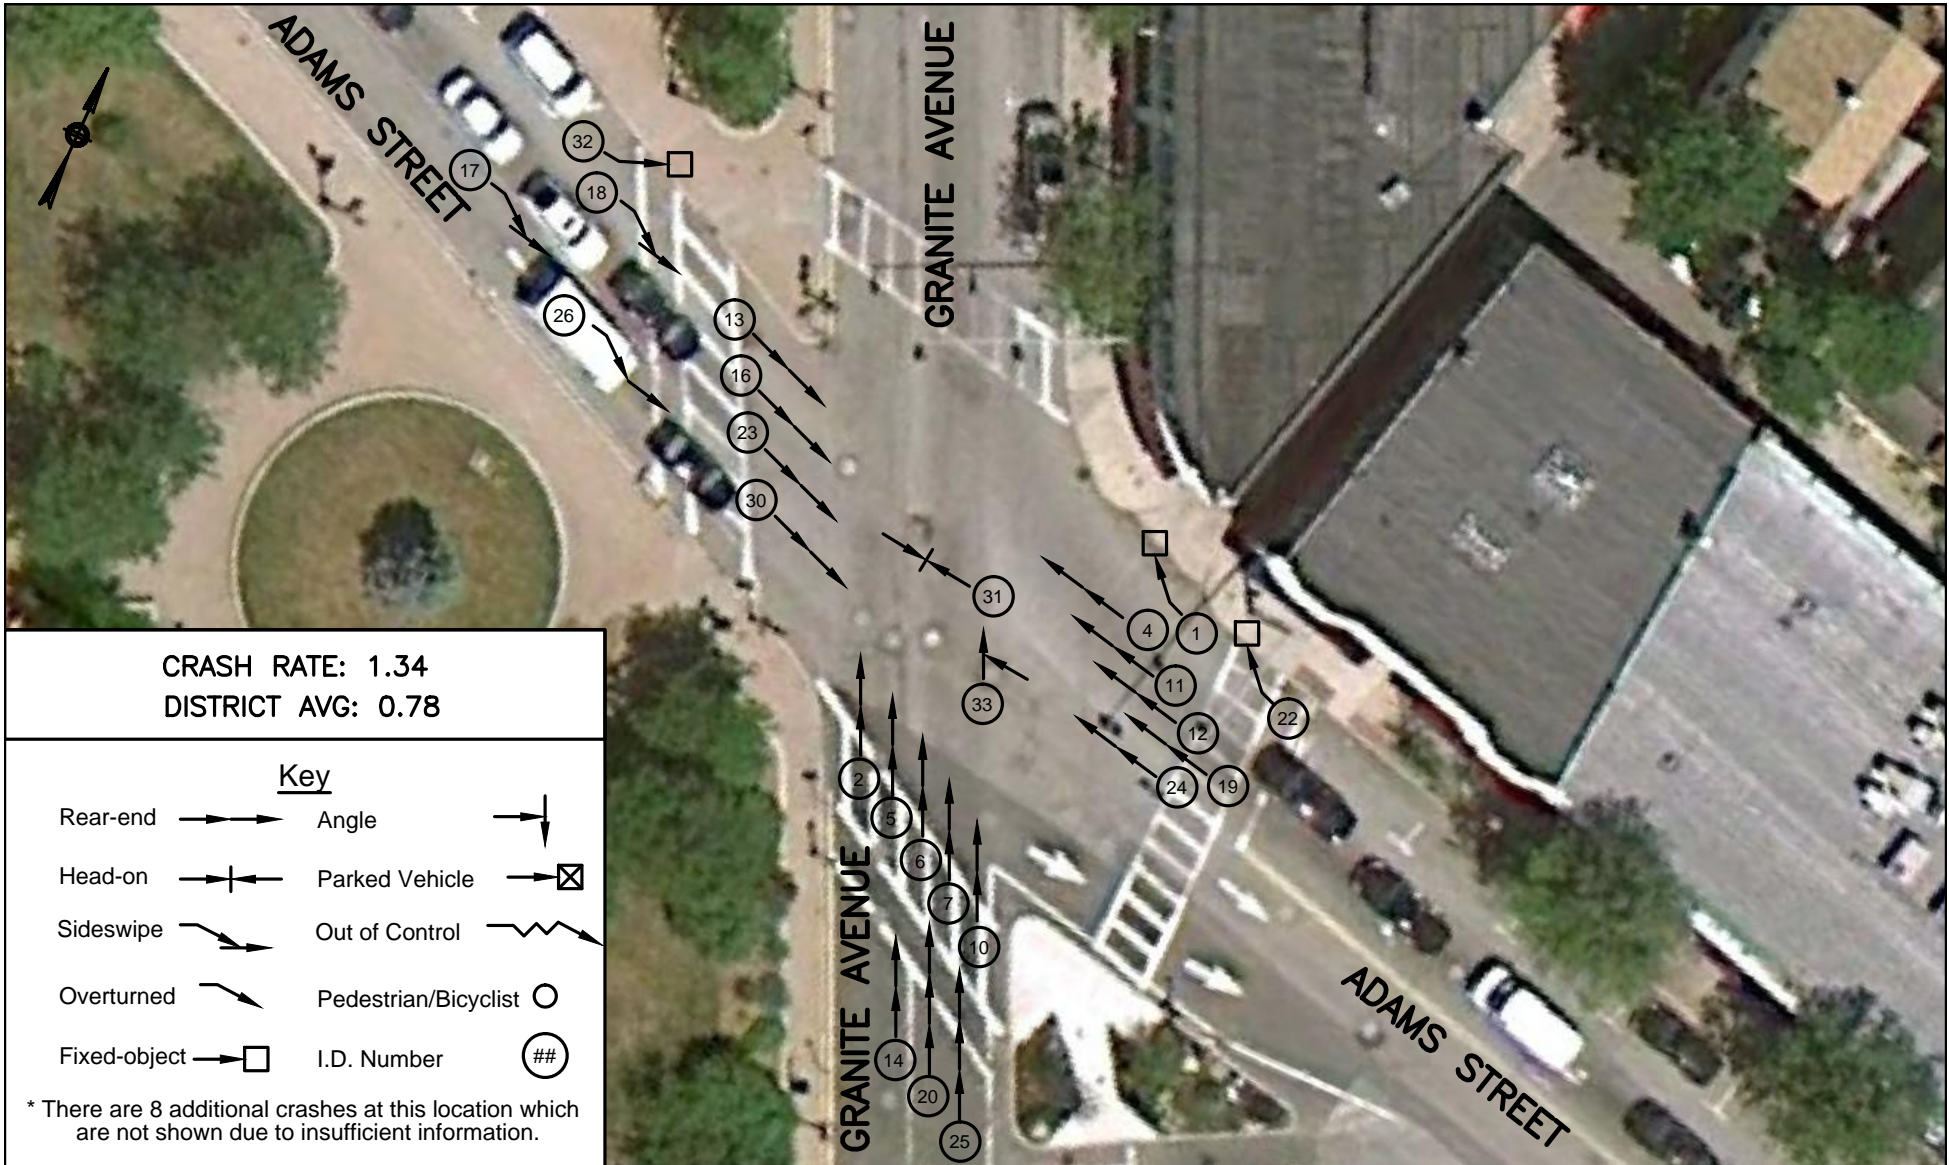
FIGURE:	HSH-SK01		
DATE:	02/09/11		
JOB:	2010053		
SCALE:	NTS		
REV: 0	BY:	AWS	
DWG REF:

CRASH RATE: 1.34  
DISTRICT AVG: 0.78

\* There are 8 additional crashes at this location which are not shown due to insufficient information.
